## Infrared Thermography Report

### *Example*

An Infrared thermography survey was recently conducted at the XXXX facility. This report highlights any equipment with identified faults or that requires repair work. During the survey completed on x/xx/20xx, we discovered 3 items that could be an immediate detriment to equipment and 4 items that warrant further attention of 128 assets scanned.

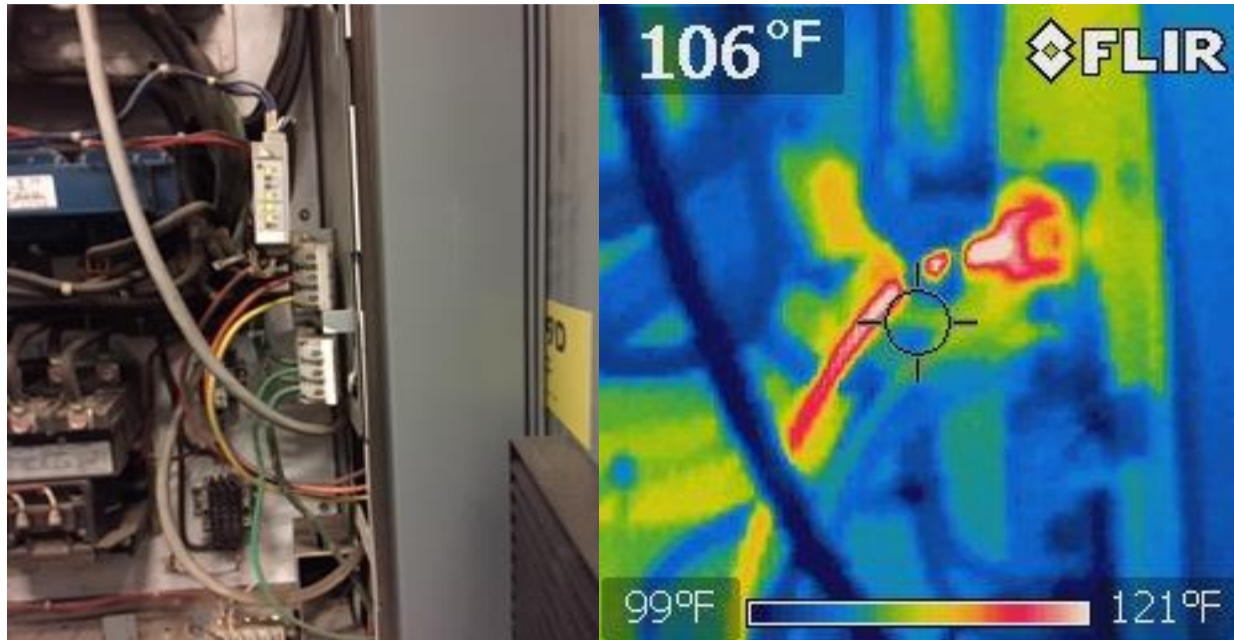
### MCC-X-3A LTG PNL 120/208V Lighting Panel \*Suggestion

480V MCC-1 located in Motor room.

There are currently 3 wires landed under one terminal on circuit breaker 11. There was no significant heat or current draw present at the time of the scan. The breaker terminals are only rated for a two-wire termination. First suggestion would be to determine whether one of the three circuits could be relocated to an available breaker. Note: pig-tailing within the panel is not an option however as it is against NEC code to splice within a distribution/branch circuit panel.

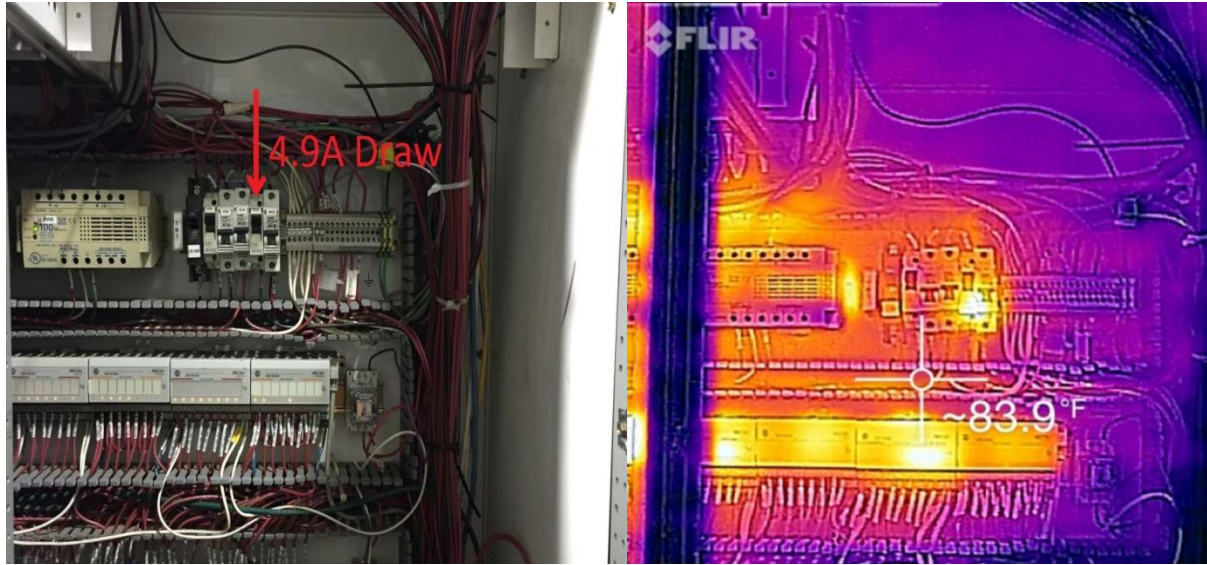
## MCC-X-7A/8A MCC Control Panel \*Suggestion

480V MCC-1 located in Motor Room.

Circuit breaker #45 is currently drawing 4.9A and is rated for 5A. There is no immediate cause for concern. We included it for information purposes in the event that the site looks to add control components to an area this circuit currently feeds.

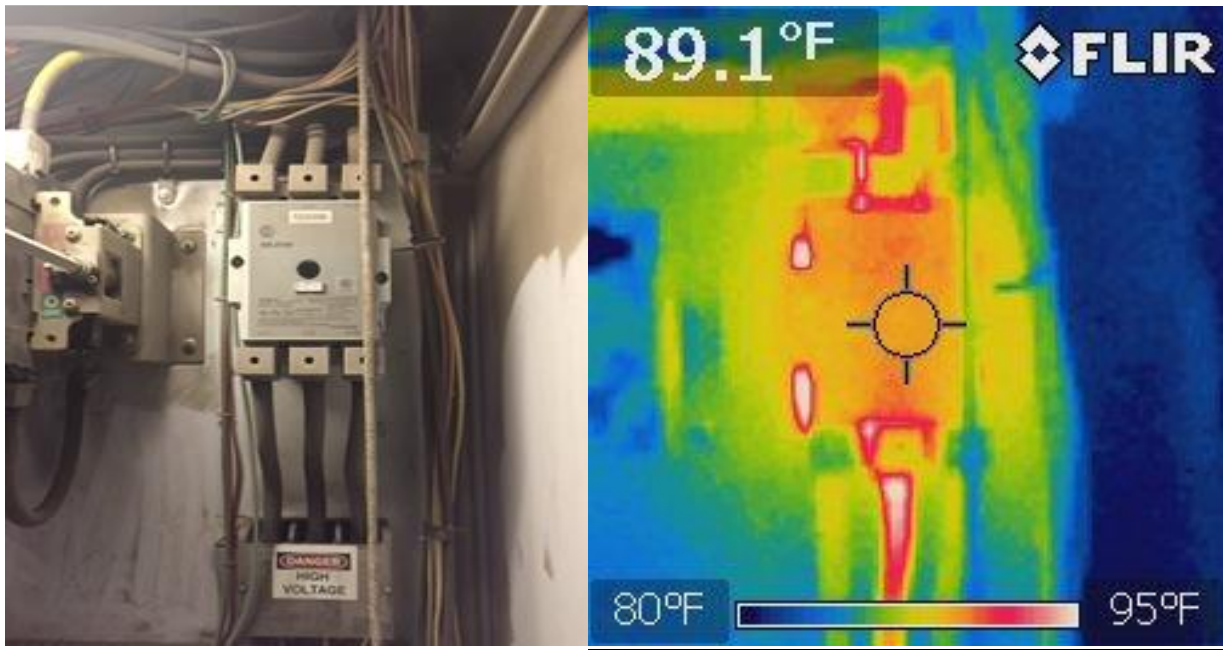
**X Panel Bank – Panel X 120/208V** \*Suggestion

120/208V panel located in X panel bank in Motor Room.

Circuit Breaker #5 in Panel LSA was tripped during scanning. We did not attempt to reset as the line running and we didn't want to inadvertently cause a problem. Recommend this asset is scanned during the next round of testing.

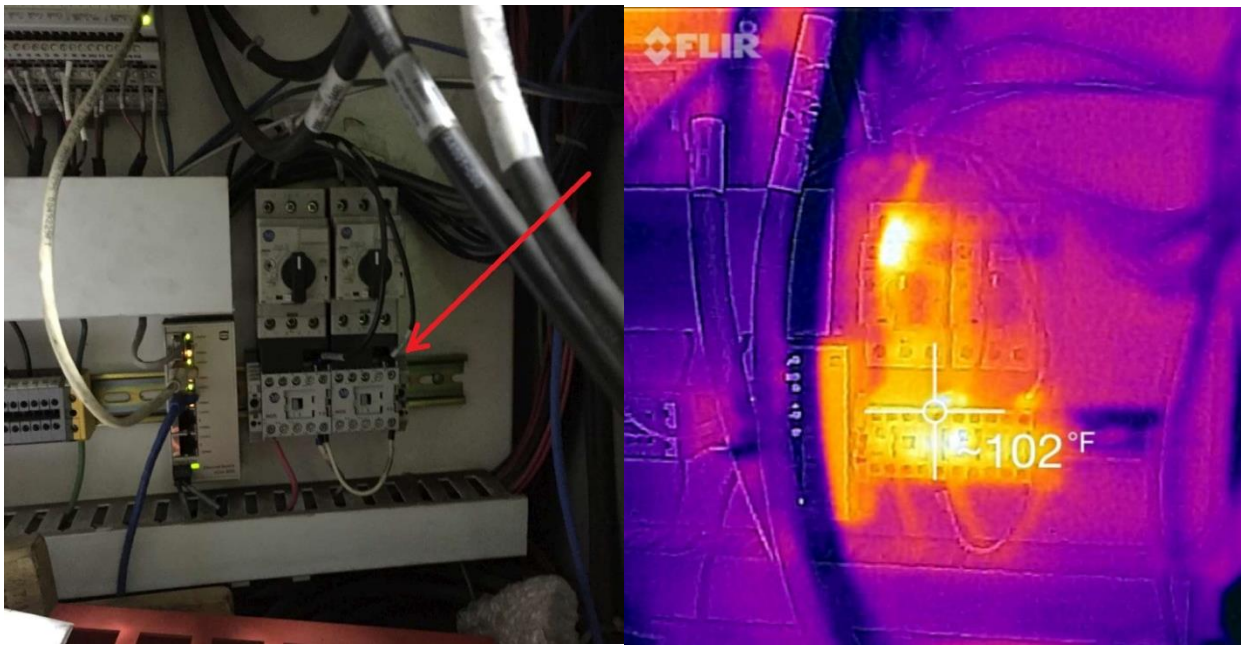
## Auto Liquid Rheostat/Arc detector Control Panel Fault Identified

Liquid rheostat control panel located in Motor Room

The “C” (T3) leg on the Contactor in the photo above scanned hot. We believe this is being caused by either a loose or faulty termination since the source of the heat is at the terminal itself. Suggest re-terminating ensuring that barrel capture engages correctly.

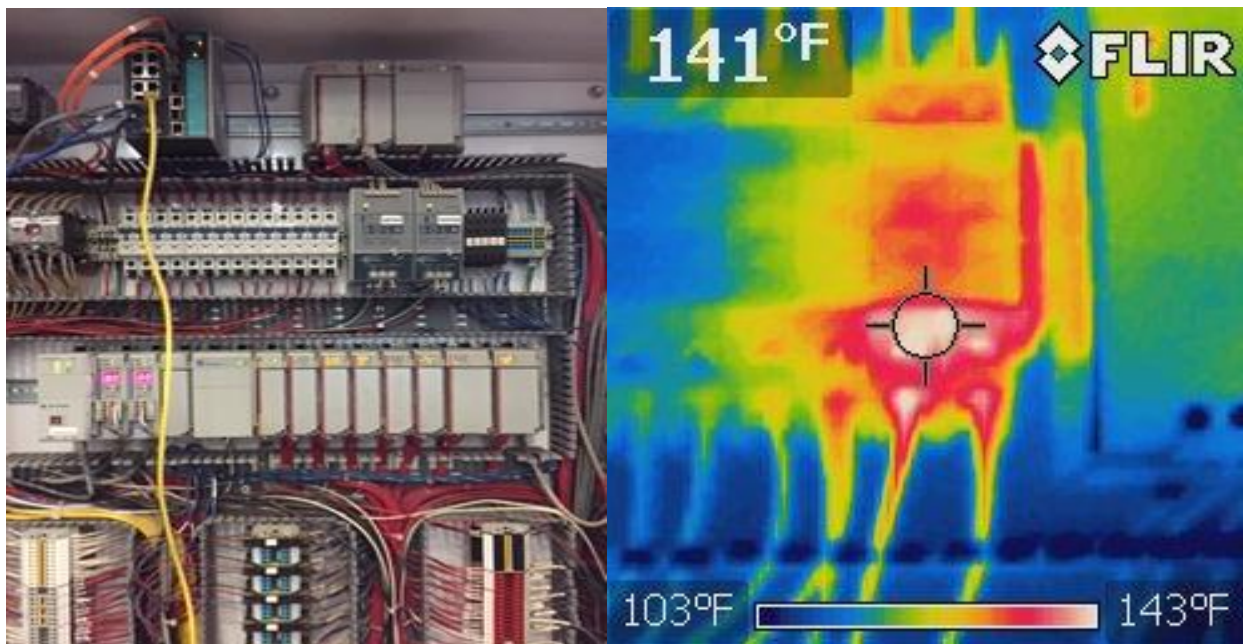
## **MCC-3-3E Fault Identified**

X Control Panel located in Building B third floor

Circuit breaker #15 (2<sup>nd</sup> to left from power supply) appears to have a loose connection causing heat at the termination point.
