Facility Safety Assessment Examples:

Plant A:

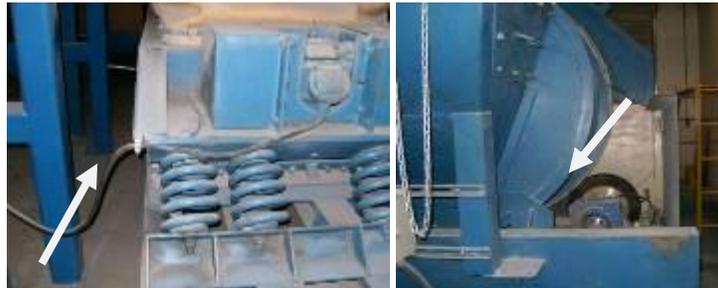
- The shaker pan under the Q100 shredder has exposed springs that need to be covered and the electrical run is improperly attached and rubs against the shaker table, which could lead to a short.
- The trommel room contains multiple pinch and entrapment points that need to be guarded.

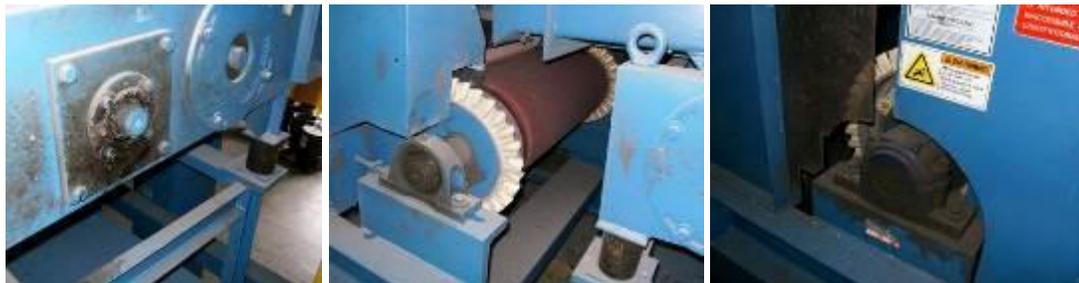
- The shaker pan before the Eddy current has exposed bearings that need to be covered.
- The Eddy current tail pulley is easily accessible and the bearing is also exposed. Suggest guarding this area with one guard that has a small access hole for greasing the bearing.

- The guarding on the head pulley of the Eddy current should fit tighter to remove the possibility from someone touching a rotating surface.

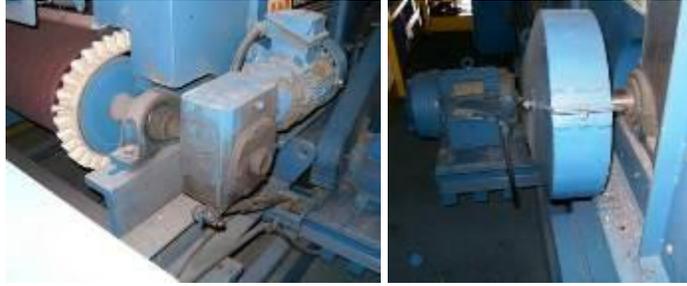
- The Eddy drum has exposed rotating shafts and gearbox that need to be covered. The head pulley is also easily accessible from this direction and needs to be guarded.
- There is an exposed shaft that needs to be covered on the eddy current drive motor.

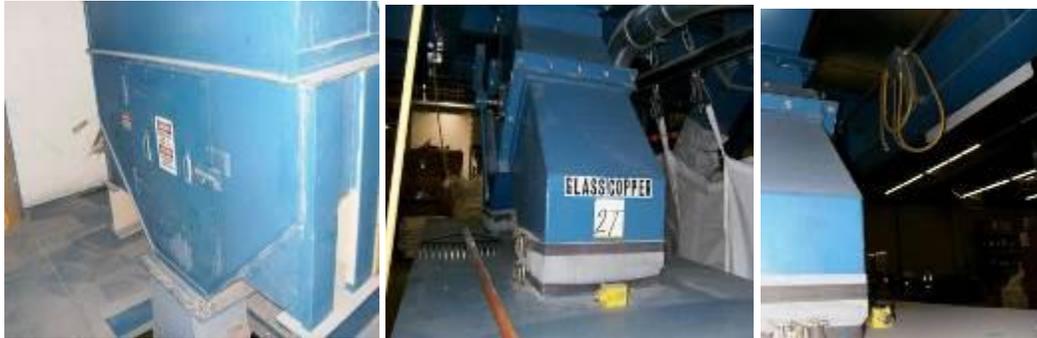
- The trommel access door does not have an interlock on it, and someone could enter the chamber during operation. An interlock switch should be added.
- The 2T Chute photo eyes have been disconnected.

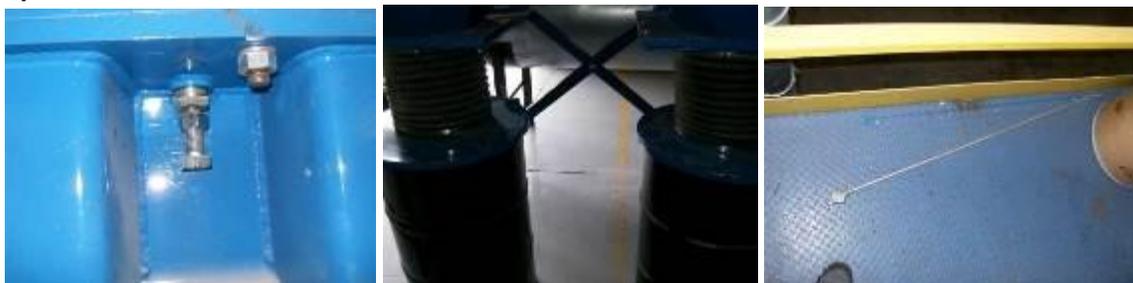
- One or more of the screen locator bolts for the Q100 are loose and can be turned by hand.
- Several of the clamps that hold the lids onto the debris drums for the bag house are missing and/or broken. They should be replaced.
- It was found that there are many air nozzles laying around machinery platforms. These compressed air nozzles should be securely stored in the maintenance area so that no unauthorized cleaning using compressed air happens. Due to the fact that no one is

issued a respirator, there shouldn't be any cleaning using compressed air anywhere in the machine area.

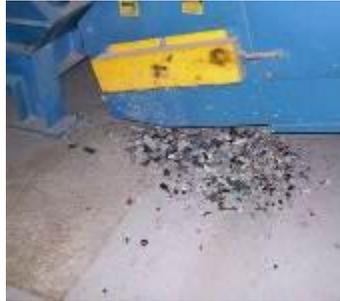
- The discharge conveyor coming from the Q100 shredder material spillage coming out of the tail pulley area that should be addressed with skirting or a custom diverter.
- There is an e-stop located near the stairs of the hammer room that is not labeled.
- There are no fall back cages on the ladders leading to the eddy current – OSHA requirement.

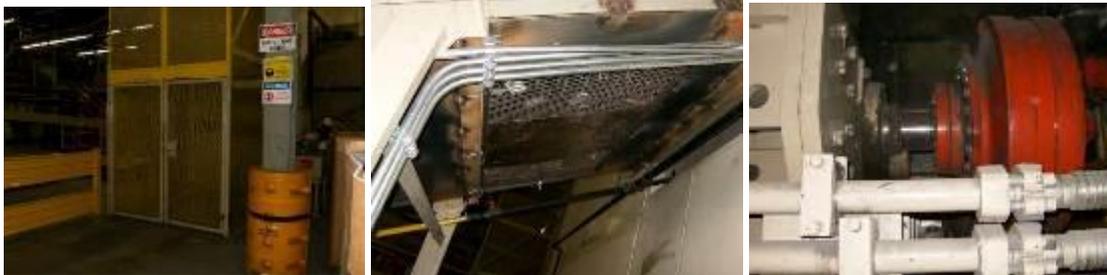
- The bin lifter's latch is bent and workers can not latch the gate closed.
- The infeed conveyor going into shredder #1 has belly pans that can be removed without the use a tools. The current clips should be replaced with fasteners that require tools to be removed.
- The rotating shaft for shredder #1 is exposed and needs to be covered.

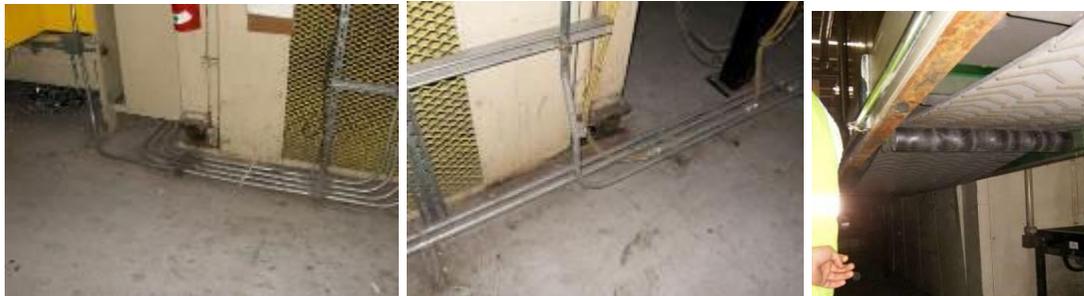
- The bin lifter has exposed bearings on both sides that need to be covered.
- The shredder #2 bypass conveyor does not have any belly pans. Pans should be made with a drop out chute.

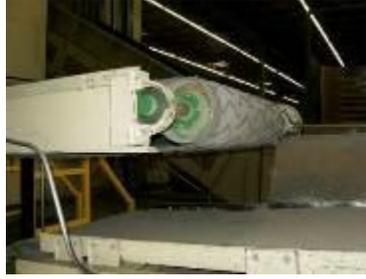
- Shredder #1 bypass conveyor has exposed bearing and exposed rollers accessible to staff that need guarding.

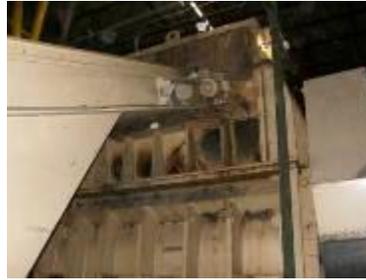
- The infeed conveyor for the Granulator is unsupported where it enters. Due to the vibration, the top of the conveyor shakes up and down several inches during operation. The conveyor need additional support to limit the possibility of the conveyor failing.

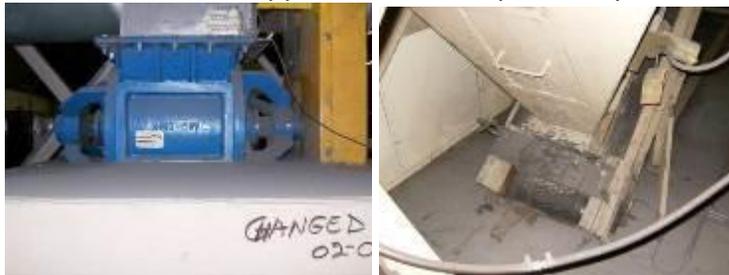
- The air lock for the bag house has several exposed shafts/bearings that need to be guarded.
- The re-dump conveyor is lacking any guarding at the tail pulley. Guards should be installed that cover both roll and the exposed bearings.

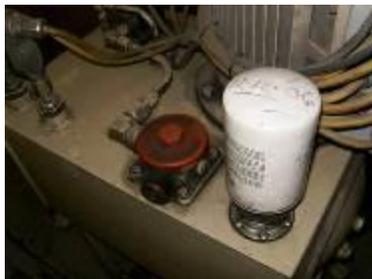
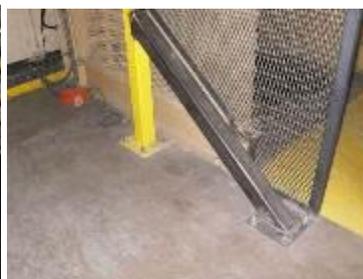
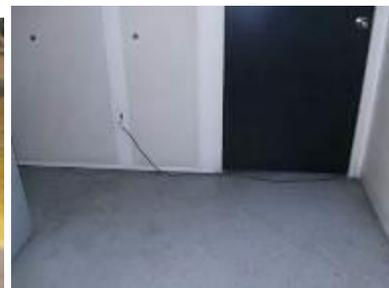
- The HPU unit for the bin lifter has a broken electrical component that needs to be fixed. (The device extends out just below the red disc.)
- The foot pedal for the new bin tipper needs to be re-located at the edge of the LOTO stand so that the operator can view what is under/around the bin when in operation.

- An extension cord was run across the floor and under the door in the MCC room. Extension cords are for temporary use and should be put away after use which should be no longer than 1 day.

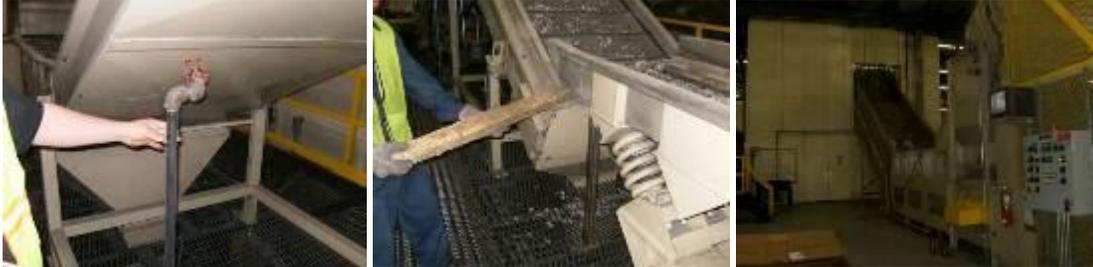
- The re-dump conveyor has a sprinkler under it that is very loose and should be supported.
- The shaker table prior to the mag-belt is easily overloaded and workers use a 2x4 to pry the table up so it will continue to flow material. Investigate improved screen media to minimize fouling.

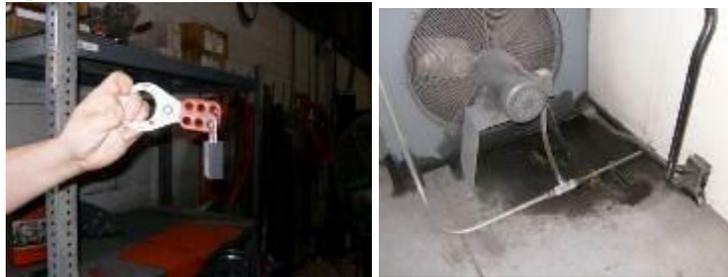
- It was observed that non-maintenance personal LOTO devices were left in seemingly random places that were not designated for LOTO locks.
- One of the HPU coolers for shredder #1 has sprung a small leak and is leaking on the floor.

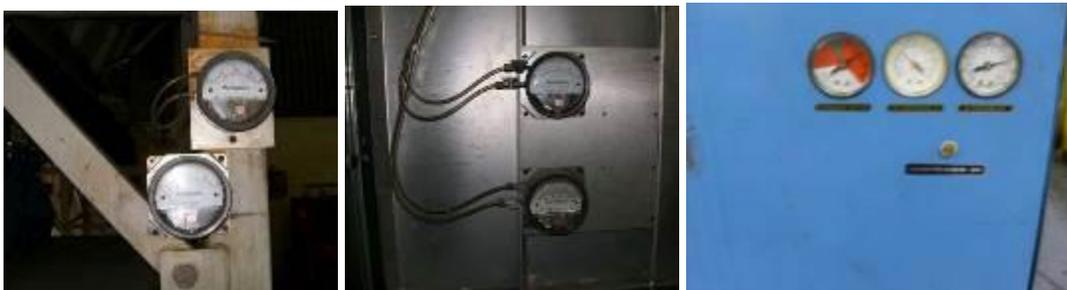
- The differential pressure gauges for the bag house do not have any performance indicators. Lines need to be placed on the gauge indicating normal operational pressure differential and at what value the machine should be shut down.
- The air compressor near the shred line is way past the safe to run temperature zone and should be investigated for low oil or a fouled cooler.
- The blower motor on the baghouse line does not have a local disconnect.

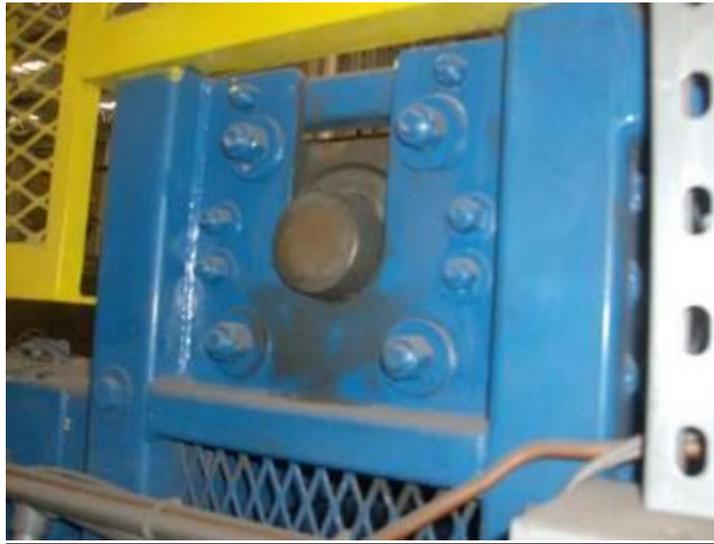
Exposed shaft on shredder bin dump

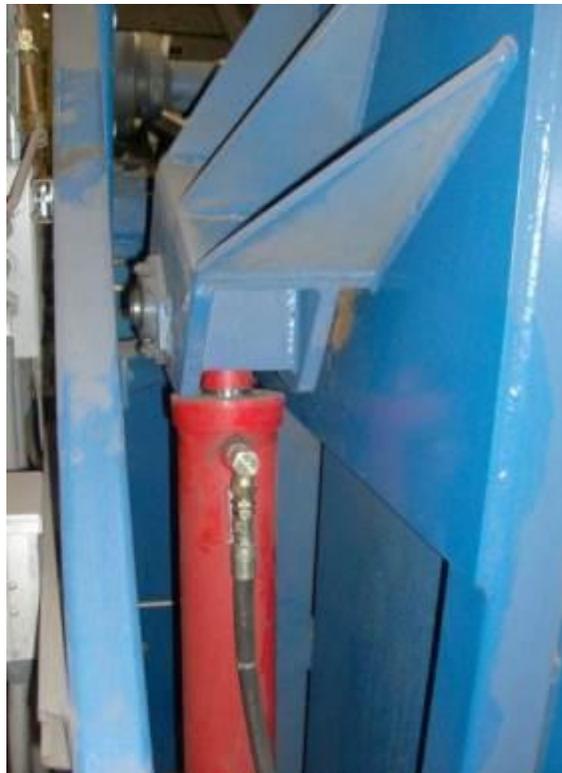
Exposed cylinder on shredder bin dump

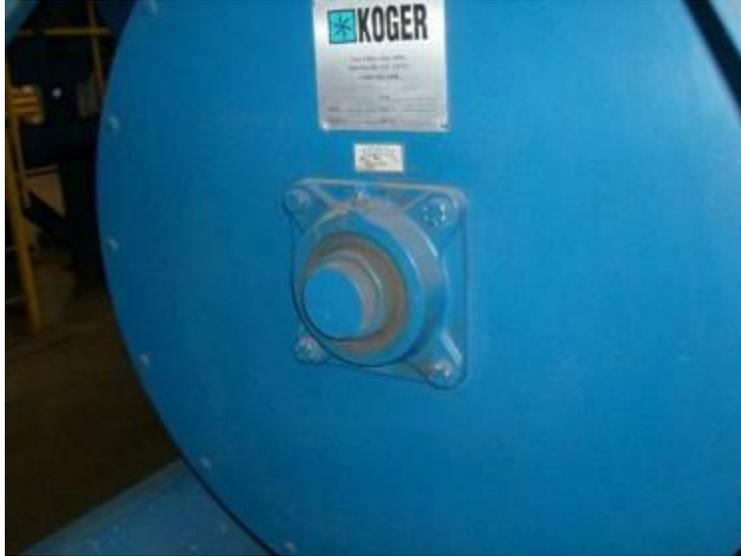
Exposed shaft cyclone rotary airgate

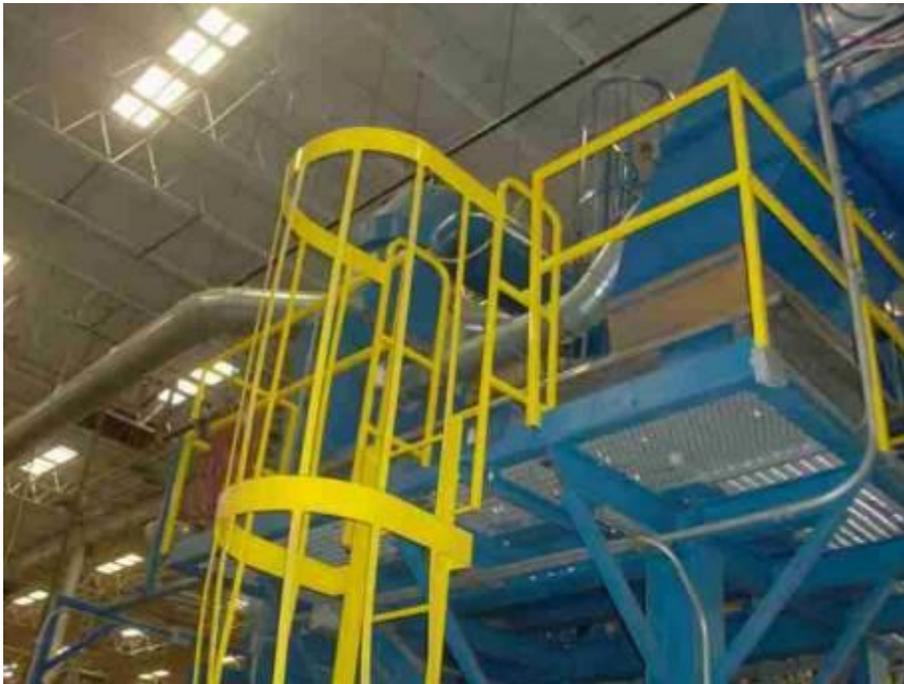
No e-stops on shred line platforms

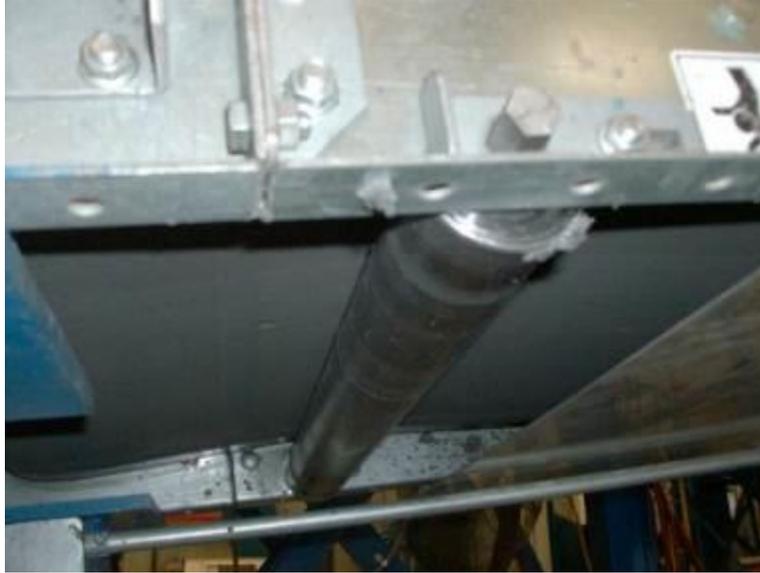
Exposed idler rollers on copper pick line

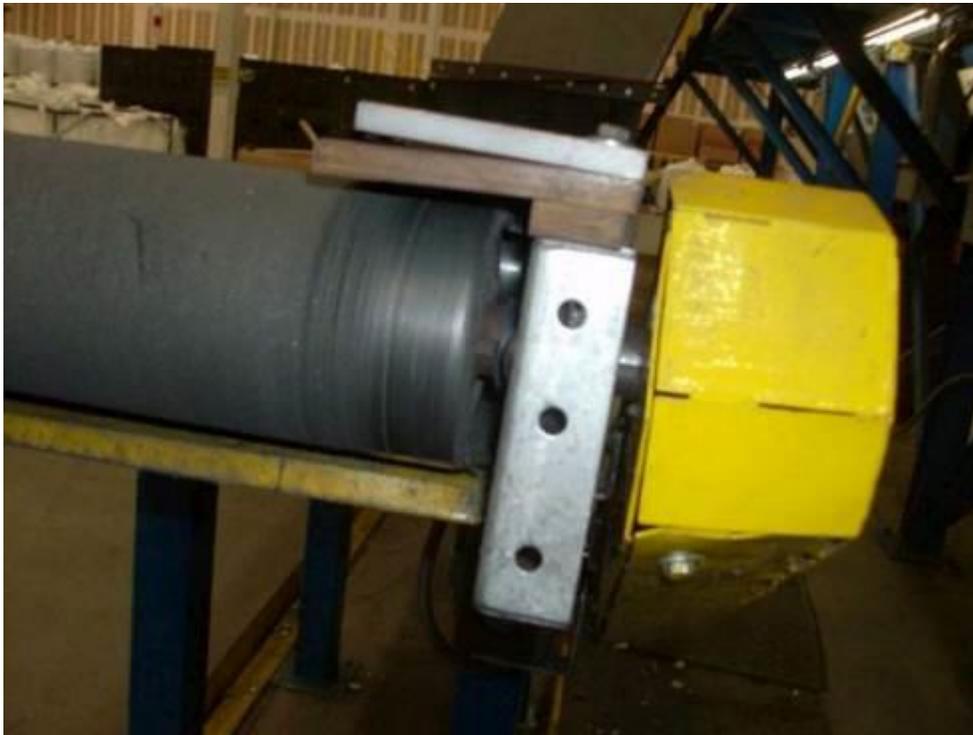
Exposed drive shaft and head pulley on copper pick line

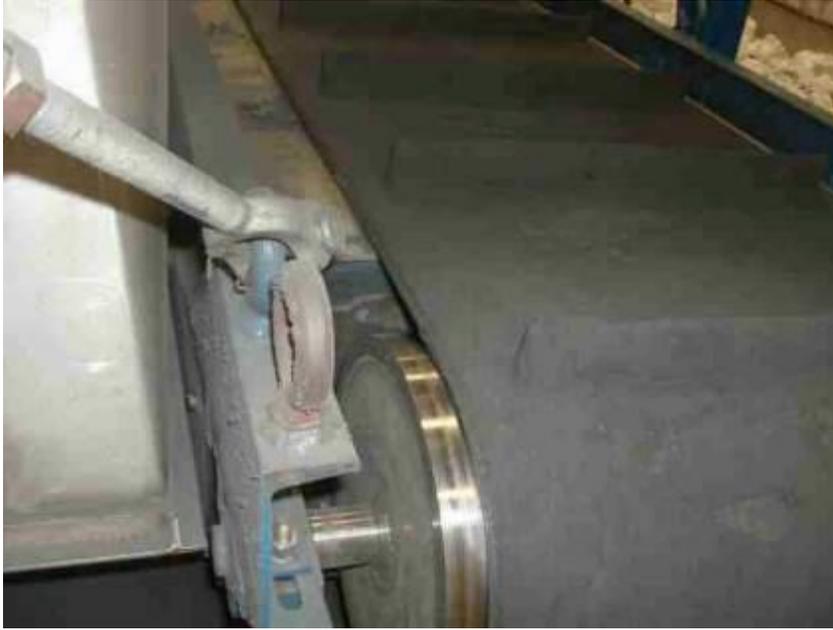
Exposed tail pulley and belt on overband mag

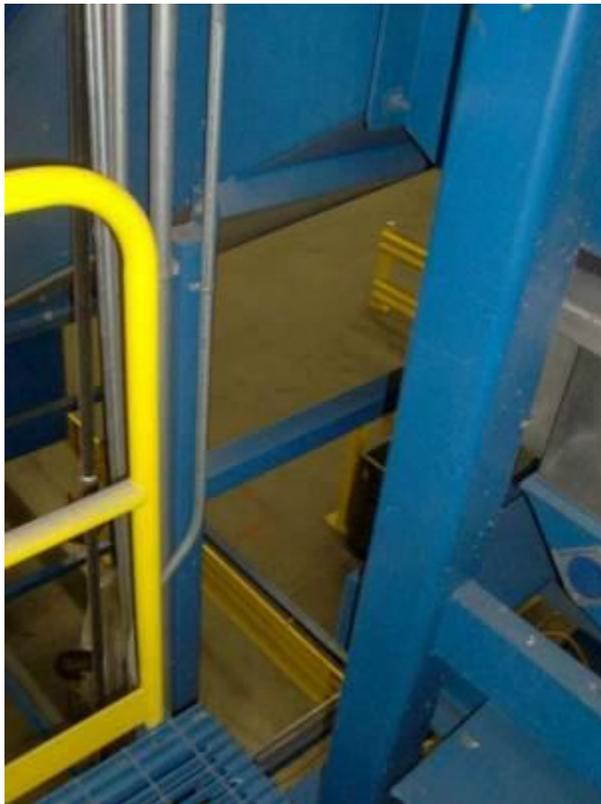
Open guardrail on overband / EC platform

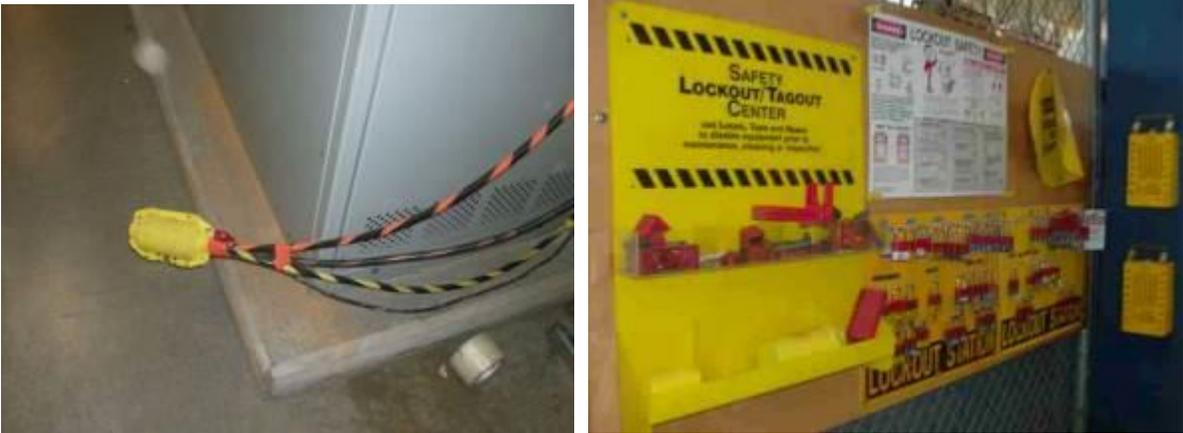
Great LOTO program

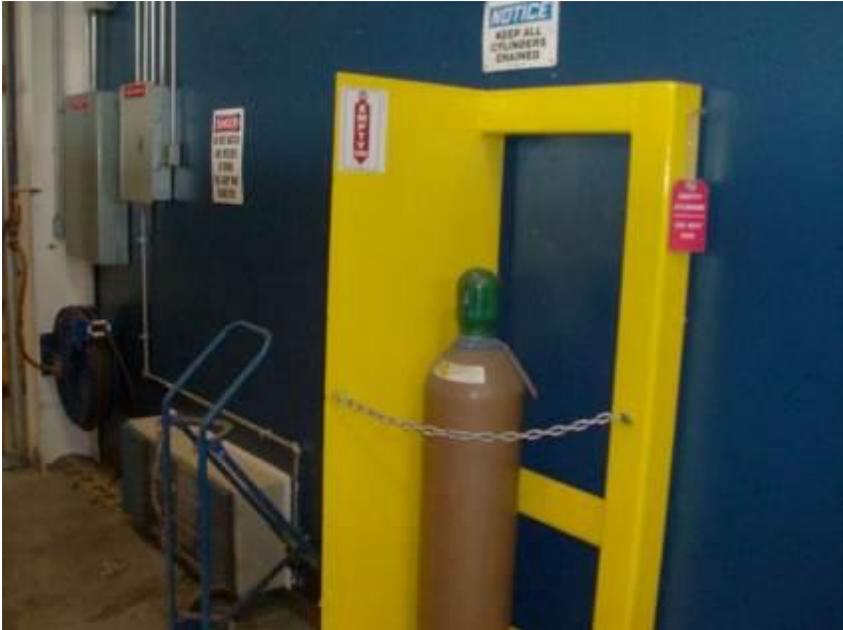
Great orphaned cylinder storage

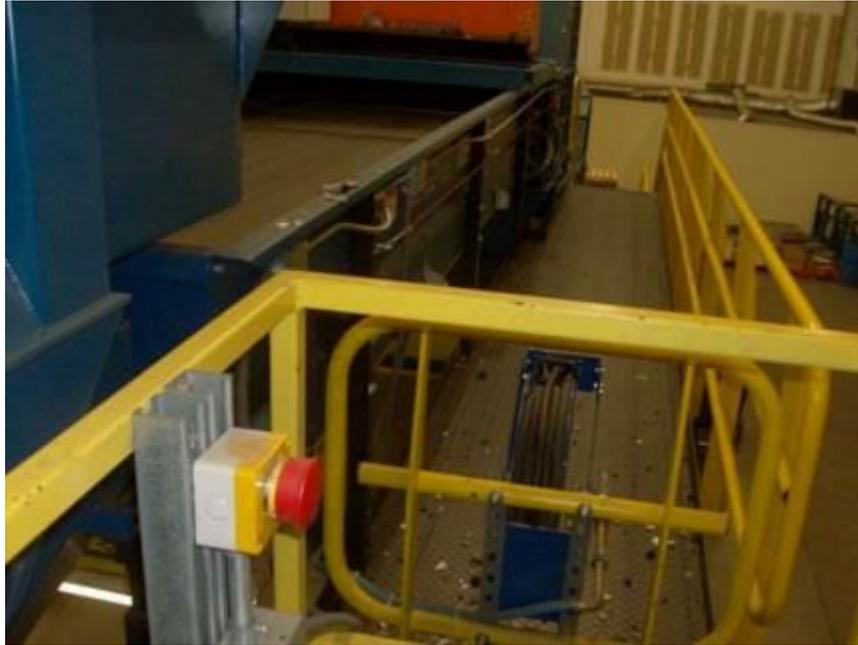
Great use of E-stops on the Sensor sorter platforms
